# Manhole Inspection Summary

Manhole # S29KK\_015MH

Insp Date: **7/10/07 9:27 AM**

**Location** Address: **1748 LAURENS ST**

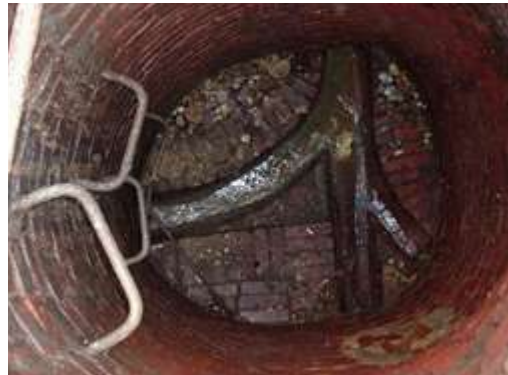
Top View

Corroded steps. Bench debris.

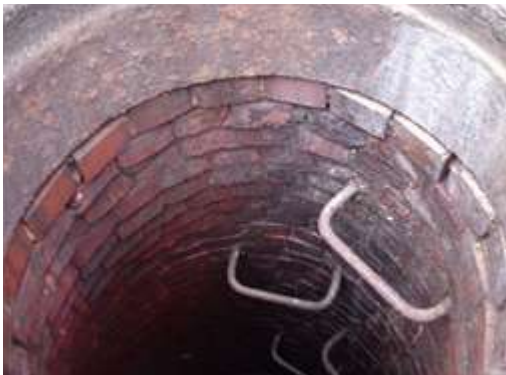
Defect

Frame leaks. Adjustment deterioration and infiltration. Corbel infiltration - other side.

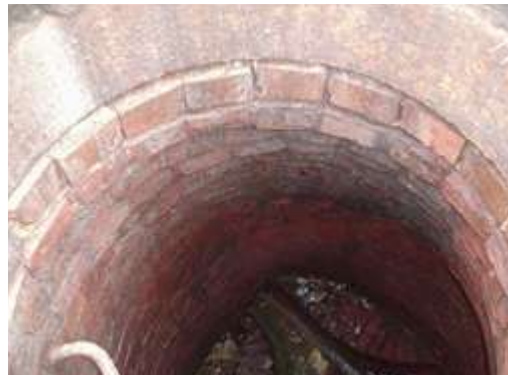
Defect

Frame leaks. Adjustment deterioration and infiltration. Corbel infiltration.

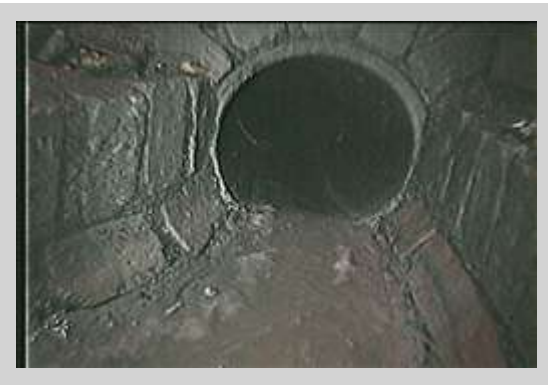
### 8 in. Circular Gravity Sewer Pipe Out @ 12 O'Clock

Channel deterioration.

Infiltration: **Evidence** Pipe Seal Cond: **Cracked**

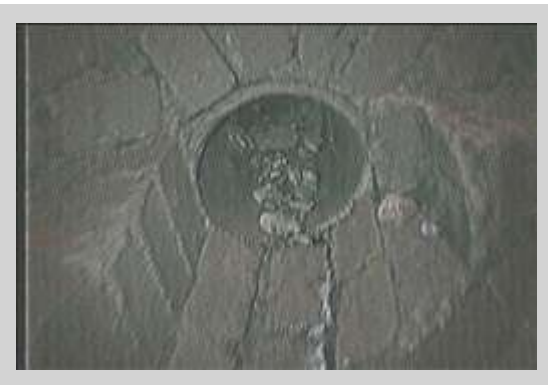
### 6 in. Circular Gravity Sewer Pipe In @ 5 O'Clock

Deposits: ☐ None ☒ **Mud** ☐ Sludge ☒ **Debris** ☐ Grease

Silt Depth: **1** (in.) Deposits Extent: **Light**

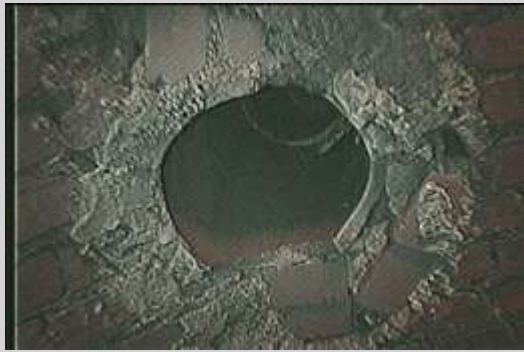
Pipe In @ 6 O'Clock

Infiltration: **Evidence** Pipe Seal Cond: **Cracked**

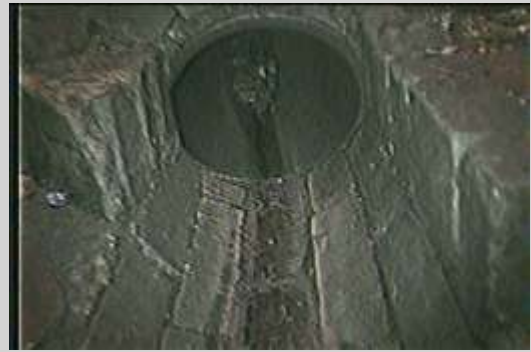
Drop In @ 6 O'Clock

Drop: **Outside** Rod and Bar  
Angled: **Yes** Reading: **8.30** (ft.)  
Inv Depth: **9.30** (ft.)  
Drop Condition: **Open**

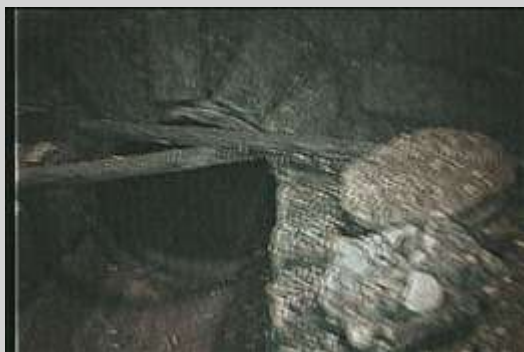
Pipe In @ 9 O'Clock

Infiltration: **None** Pipe Seal Cond: **Broken**
